**FALL DEFENSE™**

Performance Analysis of Vinyl Flooring Systems with and without  
Viconic Fall Defense™

**8/8/2024**

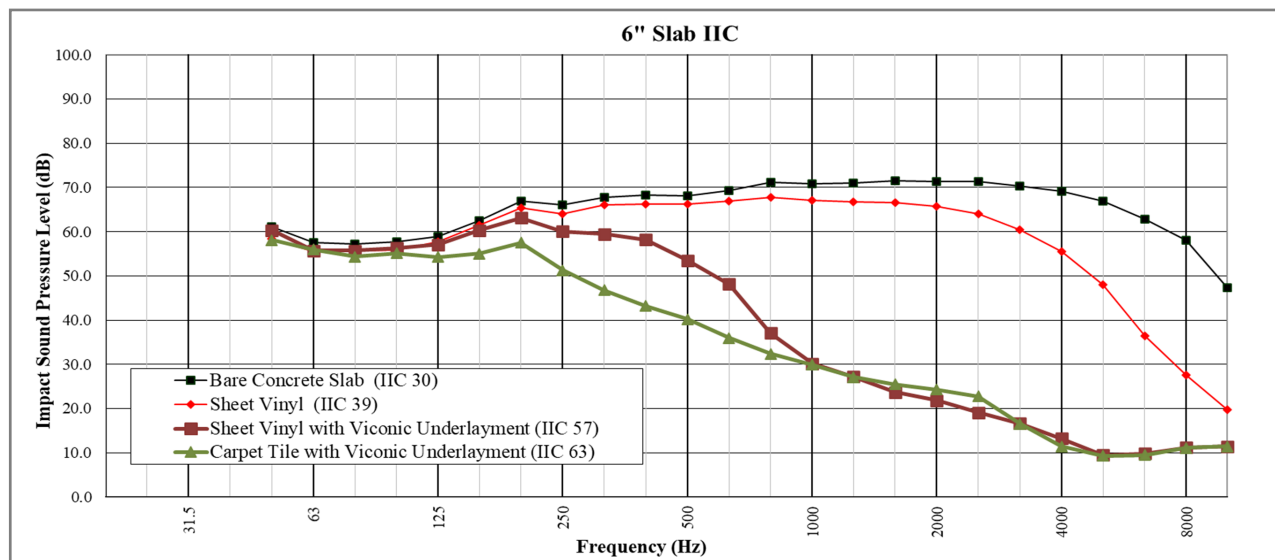
Figure 19: IIC Curves with Concrete Substrate

Viconic Fall Defense™ was evaluated by an independent test lab to determine Impact Insulation Class (IIC) over two subfloor systems commonly used in commercial construction, 152 mm concrete slab and 457 mm open web truss. Additionally, two flooring systems were adhered to the Viconic layer and evaluated, 2.2 mm commercial vinyl sheet and 5.5 mm commercial carpet tile. To measure IIC, two test rooms are needed, a source room and a receiving room where the source room is located above the receiving room with the floor/ceiling assembly acting as a barrier. A standardized tapping machine taps the floor of the source room and microphones in the receiving room measure the sound levels at predetermined frequencies. Lower levels of measured sound pressure signify less sound transmission between rooms. Impact sound pressure is plotted against frequency and the IIC rating is calculated. Figures 19 and 20 show the performance of Viconic Fall Defense™ in conjunction with vinyl sheet and carpet over a concrete subfloor and open web truss subfloor, respectively.

**Analysis** - Figure 19 clearly shows the acoustic benefits provided by Viconic Fall Defense™. Lower curves indicate lower levels of sound transmission from the source room into the receiving room. Although the curves are largely similar in lower frequencies, Viconic shows a vast improvement in mid to high frequencies. Lower frequencies are typical of “thud” type impacts from the source room such as dropped objects or someone walking heavily on their heels. The mid to high frequencies are typically associated with “click” type impacts such as the sound of walking in hard-soled shoes. Viconic’s ability to reduce noise transmission in the mid to high frequencies has a significant effect in IIC ratings. The concrete baseline increased from 30 IIC to 39 IIC with the addition of a commercial grade vinyl sheet. The same floor covering combined with a Viconic Fall Defense™ increased the IIC value to 57, a 46% improvement. Furthermore, combining Viconic with a commercial grade carpet provided an IIC rating of 62, more than doubling the IIC value of the concrete baseline.

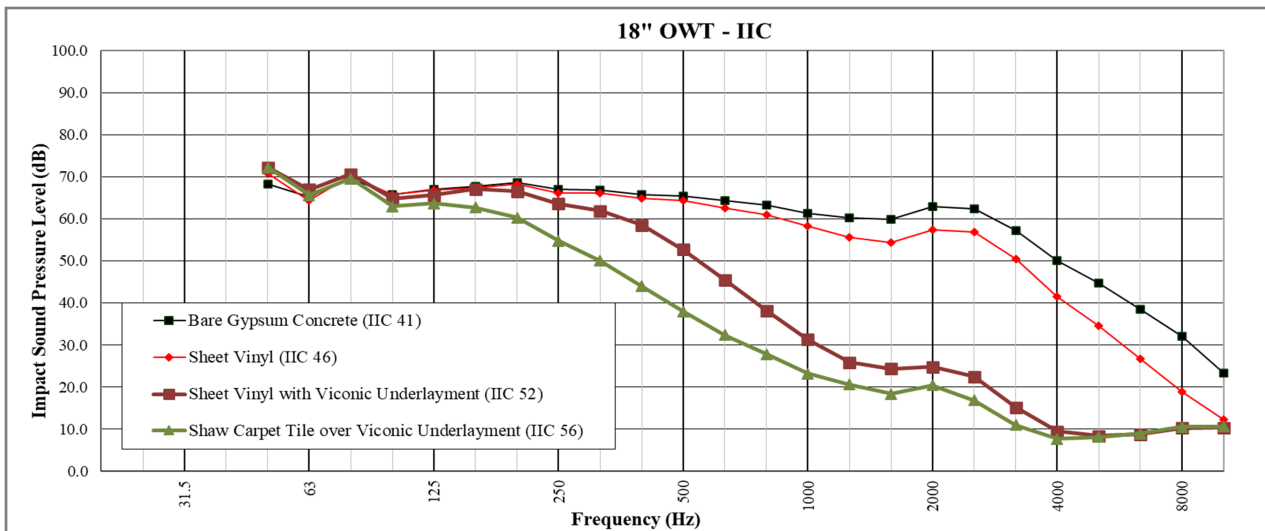
Figure 20: IIC Curves with Open Web Truss Substrate

**Analysis** - Figure 20 shows that adding Viconic Fall Defense™ also improves acoustics when using an open web truss subfloor construction. The subfloor without any floor covering had an IIC rating of 41 which increased to 46 IIC with the addition of a commercial vinyl sheet. The same vinyl sheet combined with Viconic increase the IIC value to 52, a 13% improvement. As seen with the concrete subfloor construction, combining Viconic with a commercial grade carpet further reduced sound transmission between rooms, improving to 56 IIC, a 37% improvement compared to the baseline subfloor.

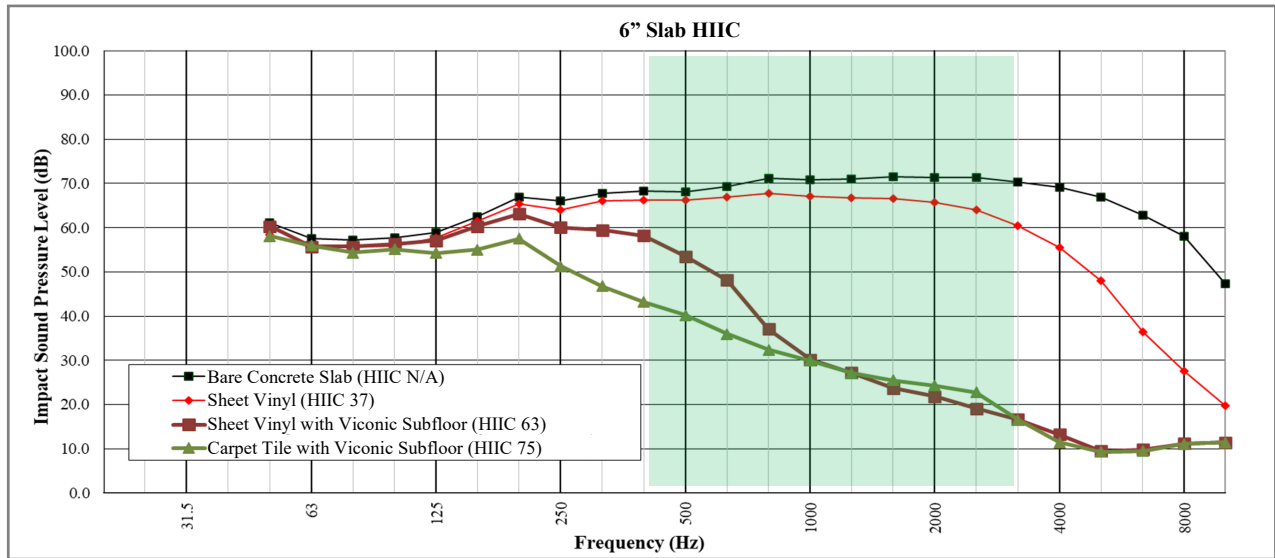
Figure 21: HIIC Test Results

The same test procedure used to determine IIC is used to determine High-Frequency Impact Insulation Class (HIIC); however, only high frequency pressure levels are used in the calculations, specifically 400Hz to 3150Hz. HIIC better highlights the acoustical improvements provided by flooring and underlayments compared to IIC. This test is only conducted over a 152mm concrete slab subfloor. Figure 21 shows the results of the HIIC test and highlights the frequencies used to calculate HIIC.

**Analysis** - Figure 21 shows the significant performance improvement offered by the Viconic Fall Defense™ system when focused on high-frequency sound transmission. HIIC for commercial grade sheet vinyl was increased from 37 HIIC to 63 HIIC with the addition of Viconic, a 70% performance improvement. Implementing a commercial grade carpet further improved acoustic properties, increasing the HIIC value to 75, more than doubling the HIIC value of vinyl over concrete. These results clearly highlight the ability of Viconic to improve facility acoustics and increase quality of life for residents.
