Viconic Sporting DBA Viconic Health

Performance Analysis of Vinyl Flooring Systems with and without  
Viconic Fall Defense™

**8/8/2024**

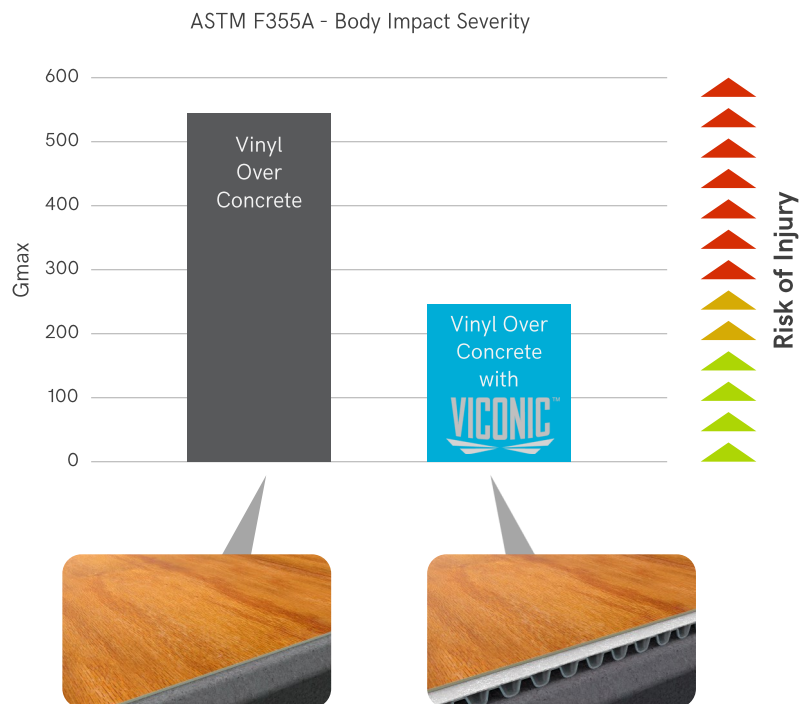
Figure 9: F355 A Missile GMAX Results

**Analysis** - Figure 9 clearly shows that the Viconic system substantially reduces the risk of body injury compared to the baseline vinyl system (545 GMAX). The Viconic system under vinyl (246 GMAX) had values at roughly the allowable GMAX for synthetic turf playing surfaces. The Viconic system's GMAX values are less than half that of the baseline system and demonstrate the capability of substantially reducing the frequency and severity of body impact injuries, including fractures, when compared to the baseline system.

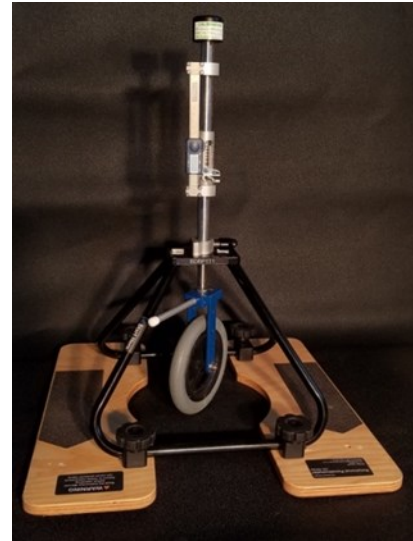
Figure 13: Rotational Penetrometer

Energy absorbing flooring surfaces may absorb impact energy and reduce risk of injury, but if too soft, can restrict mobility and increase the occurrence of falls. Performance testing to quantify the firmness and stability of surfaces was conducted using the Rotational Penetrometer in Figure 13. The device simulates the loading of a wheelchair caster and measures the depth of penetration statically (firmness) and after a 360° rotation (stability). Deformation must be below 7.6 mm for a surface to be considered firm and 12.7 mm for a surface to be considered stable. Although the addition of an energy absorbing underlayment negatively affected the values for both firmness and stability, all values still fell well within the criteria for a firm and stable flooring surface. Figures 14 and 15 compare the firmness and stability of four flooring systems.

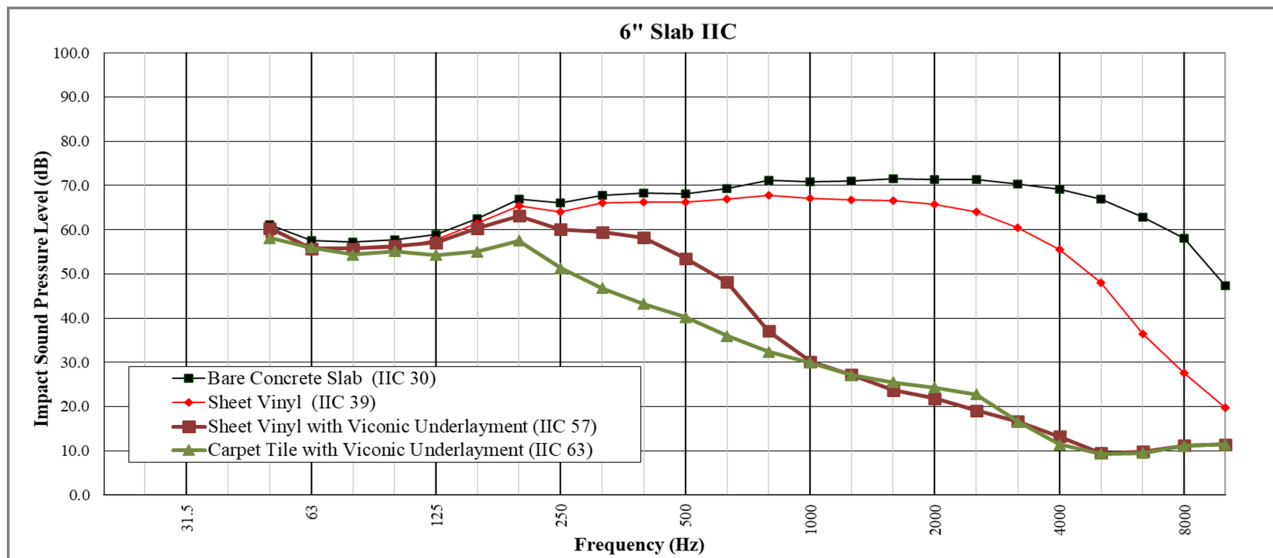
Figure 19: IIC Curves with Concrete Substrate

Viconic Fall Defense™ was evaluated by an independent test lab to determine Impact Insulation Class (IIC) over two subfloor systems commonly used in commercial construction, 152 mm concrete slab and 457 mm open web truss. Additionally, two flooring systems were adhered to the Viconic layer and evaluated, 2.2 mm commercial vinyl sheet and 5.5 mm commercial carpet tile. To measure IIC, two test rooms are needed, a source room and a receiving room where the source room is located above the receiving room with the floor/ceiling assembly acting as a barrier. A standardized tapping machine taps the floor of the source room and microphones in the receiving room measure the sound levels at predetermined frequencies. Lower levels of measured sound pressure signify less sound transmission between rooms. Impact sound pressure is plotted against frequency and the IIC rating is calculated. Figures 19 and 20 show the performance of Viconic Fall Defense™ in conjunction with vinyl sheet and carpet over a concrete subfloor and open web truss subfloor, respectively.

**Analysis** - Figure 19 clearly shows the acoustic benefits provided by Viconic Fall Defense™. Lower curves indicate lower levels of sound transmission from the source room into the receiving room. Although the curves are largely similar in lower frequencies, Viconic shows a vast improvement in mid to high frequencies. Lower frequencies are typical of “thud” type impacts from the source room such as dropped objects or someone walking heavily on their heels. The mid to high frequencies are typically associated with “click” type impacts such as the sound of walking in hard-soled shoes. Viconic’s ability to reduce noise transmission in the mid to high frequencies has a significant effect in IIC ratings. The concrete baseline increased from 30 IIC to 39 IIC with the addition of a commercial grade vinyl sheet. The same floor covering combined with a Viconic Fall Defense™ increased the IIC value to 57, a 46% improvement. Furthermore, combining Viconic with a commercial grade carpet provided an IIC rating of 62, more than doubling the IIC value of the concrete baseline.
