Viconic Sporting DBA Viconic Health

Performance Analysis of Vinyl Flooring Systems with and without
Viconic Fall Defense™

2/5/2025

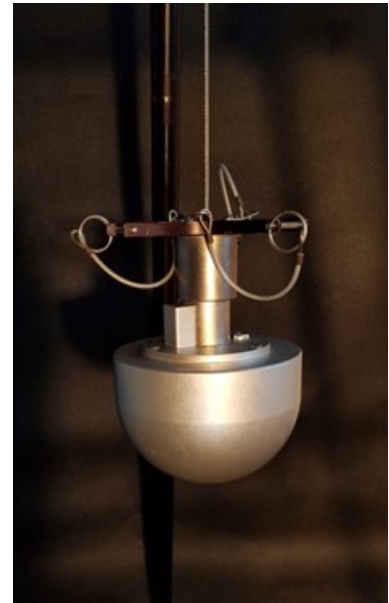
An independent test lab was contracted to evaluate the head impact attenuation properties of Viconic Fall Defense™ using the ASTM F355 E-Missile (Figure 4). This device is commonly used for assessing playground surfaces globally per ASTM F1292. It lacks a human like skin but outputs a worst case (HIC) from a surface impact. The impact mechanism consists of a 10 lb hemispherical aluminum missile equipped with a tri-axial accelerometer that has various fall height capabilities. The HIC value is calculated from an integration of the acceleration-time graph during an impact. Lower HIC values are indicative of lower risk of injury. Furthermore, HIC values under 1000 are desired and required under federal standards. At 1000 HIC there is very high risk of moderate head injury and a 3% chance of critical injury. The probability of critical injury increases exponentially as HIC scores increase above 1000. Figure 5 compares the HIC response of the flooring systems at a drop height of 0.6 m.

Figure 4: ASTM F355 E Missile

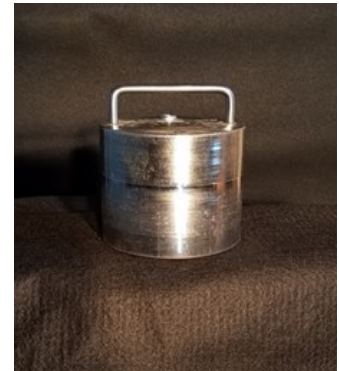
An independent test lab was contracted to evaluate the body impact attenuation properties of Viconic Fall Defense™ using the ASTM F355 A-Missile, which has long been used in North America to gauge the hardness and safety of synthetic turf playing surfaces. The device (as pictured in Figure 8) is a 9.1 kg test missile with a 12 cm flat bottom. The device outputs GMAX, the maximum deceleration experienced during a drop as a multiple of G, the force of gravity. Fields that fail to achieve a GMAX of less than a limit of 200 are deemed unsafe for play. Playing surfaces above this stiffness demonstrate increased risk for bodily injury due to falls onto the surface. Lower values of GMAX during falls are generally considered to present a lower risk of bodily injury. The test protocol requires that the missile be dropped 3 times from a height of 0.61m. The first drop is a conditioning drop; the last two drops are averaged and reported. Figure 9 compares the response of the flooring systems studied here.

Figure 8: ASTM F355 A Missile

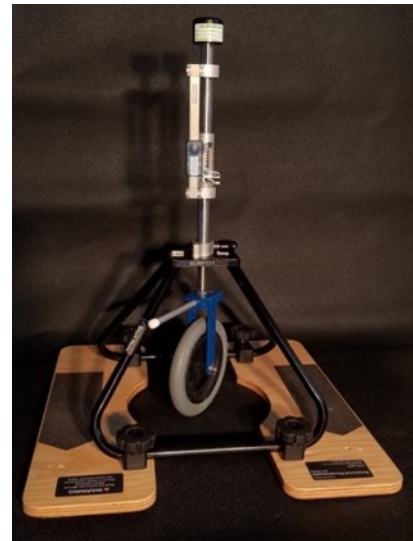
Energy absorbing flooring surfaces may absorb impact energy and reduce risk of injury, but if too soft, can restrict mobility and increase the occurrence of falls. Performance testing to quantify the firmness and stability of surfaces was conducted using the Rotational Penetrometer in Figure 13. The device simulates the loading of a wheelchair caster and measures the depth of penetration statically (firmness) and after a 360° rotation (stability). Deformation must be below 7.6 mm for a surface to be considered firm and 12.7 mm for a surface to be considered stable. Although the addition of an energy absorbing underlayment negatively affected the values for both firmness and stability, all values still fell well within the criteria for a firm and stable flooring surface. Figures 14 and 15 compare the firmness and stability of four flooring systems.

Figure 13: Rotational Penetrometer
