# VICONIC HEALTH ACOUSTICAL PERFORMANCE TEST REPORT

ASTM E90, ASTM E492, AND ASTM E2179 TESTING ON 5.5 MM CARPET TILE OVER 11 MM VICONIC SAFETY FLOORING™ UNDERLAYMENT

N6747.06-113-11-R0

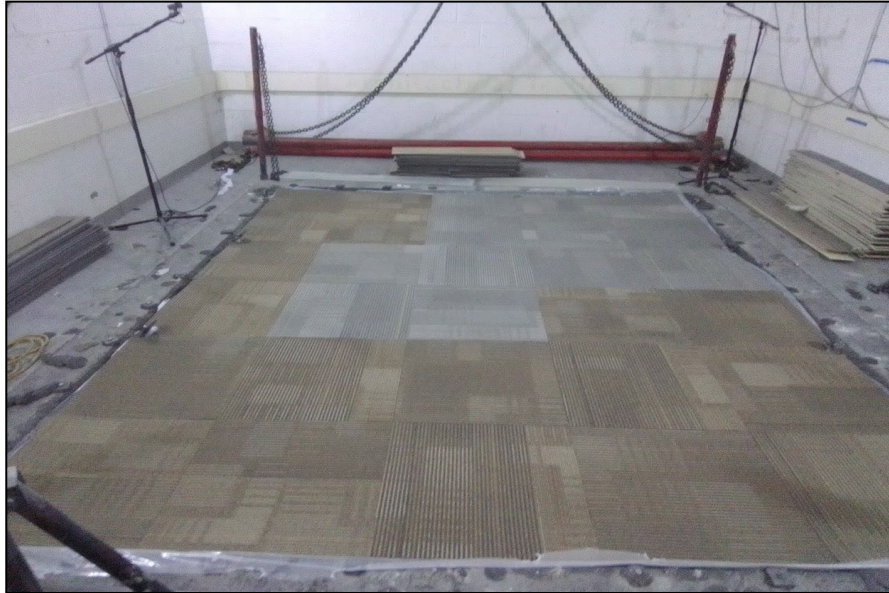
**Photo No. 1**

**Source Room View of Test Specimen Installation**

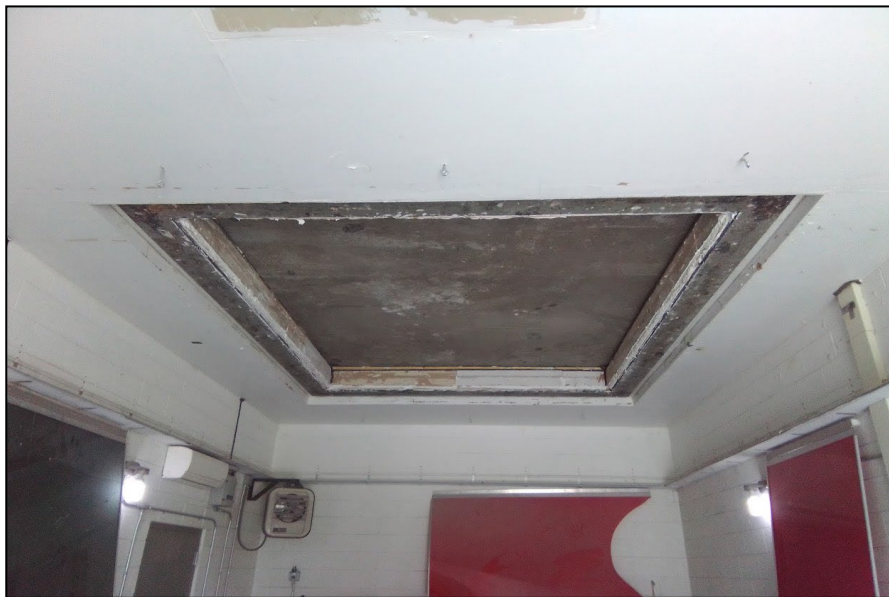
**Photo No. 2**

**Receive Room View of Test Specimen Installation**
