VICONIC HEALTH ACOUSTICAL PERFORMANCE TEST REPORT

ASTM E90, ASTM E492, AND ASTM E2179 TESTING ON 2.2 MM COMMERCIAL SHEET FLOORING OVER 11 MM VICONIC SAFETY FLOORING™ UNDERLAYMENT

Concrete Slab - 152 mm

N6747.05-113-11-R0

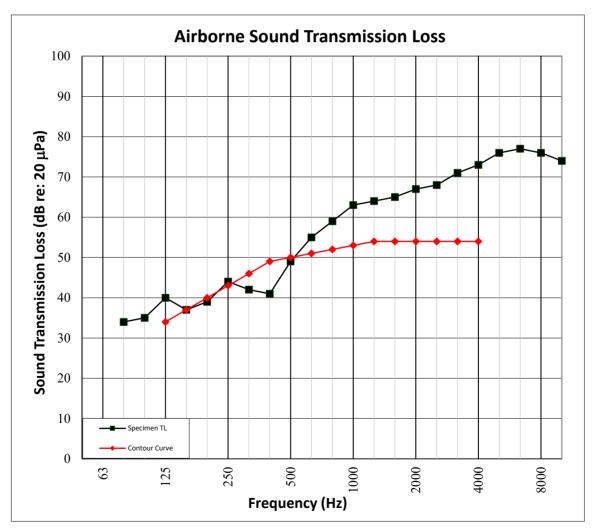
SECTION 11

TEST RESULTS - AIRBORNE SOUND TRANSMISSION LOSS GRAPH

FREQ	BACKGROUND	ABSORPTION	SOURCE	RECEIVE	SPECIMEN	95%	NUMBER
FREQ	SPL	ABSORPTION	SPL	SPL	TL	SAMPLING	OF
(Hz)	(dB)	m²	(dB)	(dB)	(dB)	LIMIT	DEFICIENCIES
50	29.8	24.1	107	68	37	5.1	-
63	27.4	19.2	106	67	37	5.5	-
80	30.3	13.8	101	67	34	3.5	-
100	22.3	10.5	98	64	35	1.5	-
125	23.8	8.3	100	62	40	2.6	0
160	18.7	8.7	97	62	37	1.6	0
200	14.3	9.5	95	56	39	1.5	1
250	11.6	9.1	97	54	44	1.0	0
315	12.5	10.2	100	58	42	1.2	4
400	8.8	8.7	99	59	41	0.9	8
500	11.7	8.2	97	49	49	0.5	1
630	14.2	7.6	97	44	55	0.7	0
800	13.5	8.2	97	40	59	0.9	0
1000	14.3	7.9	97	36	63	0.6	0
1250	12.9	7.8	96	34	64	0.5	0
1600	9.5	8.2	97	34	65	0.3	0
2000	7.8	9.1	96	31	67	0.4	0
2500	6.6	10.2	92	25	68	0.4	0
3150	6.2	11.5	92	21	71	0.6	0
4000	6.7	13.0	92	19	73	0.6	0
5000	7.4	15.0	89	13	76	0.5	-
6300	8.3	18.6	86	8	77	1.0	-
8000	9.0	24.3	87	8	76	1.3	-
10000	9.3	24.3	85	8	74	1.6	-
STC Ratin	50	(Sound Transmi	ssion Class)		Sum o	f Deficiencies	14

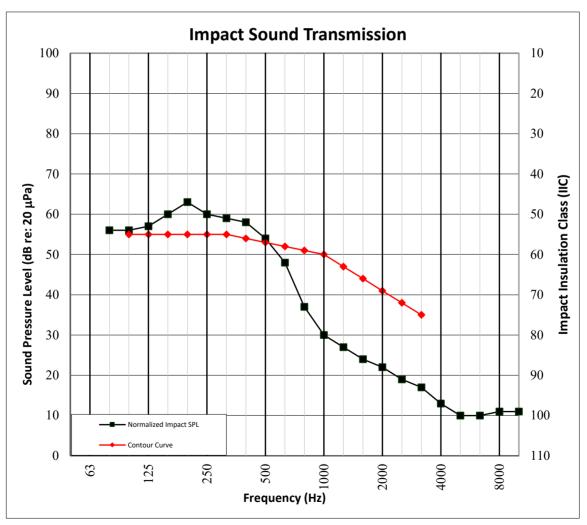
SECTION 13

TEST RESULTS - IMPACT SOUND TRANSMISSION GRAPH

FREQ	BACKGROUND SPL	ABSORPTION	NORMALIZED IMPACT SPL	95% SAMPLING	NUMBER OF
(Hz)	(dB)	m²	(dB)	LIMIT	DEFICIENCIES
80	30.1	14.1	56	2.7	-
100	24.5	10.0	56	1.3	1
125	21.6	8.6	57	1.1	2
160	17.6	9.4	60	0.7	5
200	15.9	9.0	63	0.9	8
250	12.3	9.4	60	0.5	5
315	12.5	9.9	59	0.5	4
400	9.0	8.7	58	0.4	4
500	13.3	8.1	54	0.4	1
630	12.1	7.7	48	0.3	0
800	14.2	8.0	37	0.5	0
1000	15.1	7.9	30	0.4	0
1250	12.8	7.9	27	0.4	0
1600	9.4	8.3	24	0.4	0
2000	7.9	9.3	22	0.5	0
2500	6.7	10.1	19	0.6	0
3150	6.2	11.4	17	0.7	0
4000	6.7	12.9	13	0.8	-
5000	7.4	14.9	10	0.7	-
6300	8.3	18.7	10	0.8	-
8000	9.0	24.0	11	0.9	-
10000	9.4	24.0	11	0.9	-
IIC Rating	5 7	(Impact Insulati	on Class)	Sum of Deficiencies	30

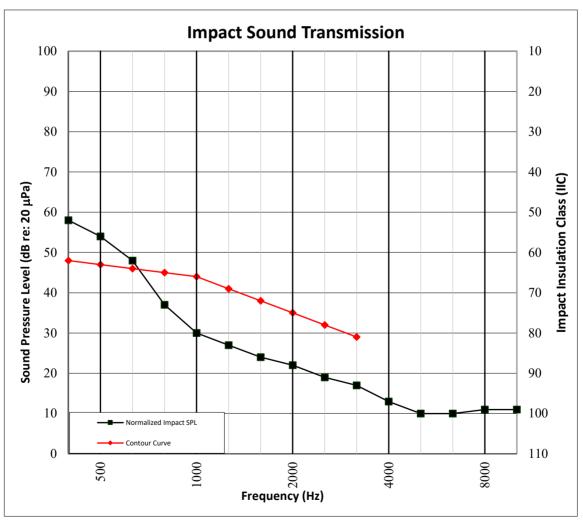
SECTION 15

TEST RESULTS - HIGH-FREQUENCY IMPACT SOUND TRANSMISSION GRAPH

FREQ	BACKGROUND SPL	ABSORPTION	NORMALIZED IMPACT SPL	95% SAMPLE CONFIDENCE	NUMBER OF
(Hz)	(dB)	m²	(dB)	LIMIT	DEFICIENCIES
400	9.0	8.7	58	0.4	10.2
500	13.3	8.1	54	0.4	6.5
630	12.1	7.7	48	0.3	2.1
800	14.2	8.0	37	0.5	0.0
1000	15.1	7.9	30	0.4	0.0
1250	12.8	7.9	27	0.4	0.0
1600	9.4	8.3	24	0.4	0.0
2000	7.9	9.3	22	0.5	0.0
2500	6.7	10.1	19	0.6	0.0
3150	6.2	11.4	17	0.7	0.0
HIIC Ratio	<mark>ng</mark> 63	(High-Frequency	/ Impact Insulation Class)	Sum of Deficiencies	18.8

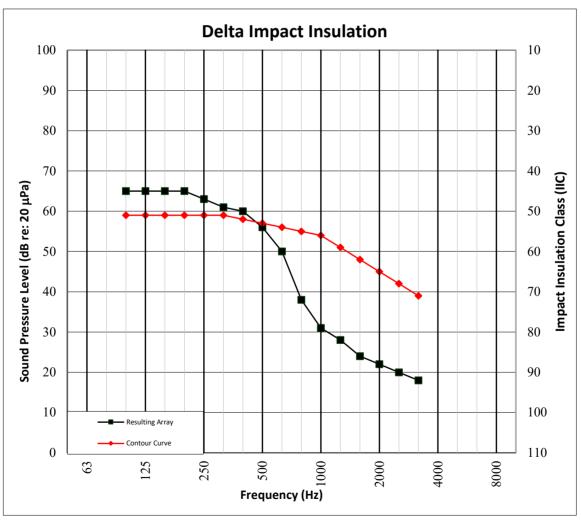
SECTION 17

TEST RESULTS - DELTA IMPACT INSULATION GRAPH

FREQ	BACK SPL	GROUND	ABSORPTION	NORMALIZED IMPACT SPL	95% CONF	NORMALIZEI		RESULT ARRAY	NUMBER OF DEFI-
(Hz)	(dB)		m²	BARE (dB)	LIMIT	SPEC (dB)	LIMIT	L _{ref,c}	CIENCIES
100	24.5		10.0	58.1	1.7	56.3	1.6	65.0	6
125	21.6		8.6	59.4	1.3	57.1	1.4	65.0	6
160	17.6		9.4	62.9	0.9	60.3	0.9	65.0	6
200	15.9		9.0	66.8	0.9	63.1	1.1	65.0	6
250	12.3		9.4	65.9	0.5	60.1	0.6	63.0	4
315	12.5		9.9	67.6	0.6	59.5	0.6	61.0	2
400	9.0		8.7	68.1	0.5	58.2	0.5	60.0	2
500	13.3		8.1	68.1	0.5	53.5	0.5	56.0	0
630	12.1		7.7	69.2	0.4	48.1	0.4	50.0	0
800	14.2		8.0	71.0	0.6	37.1	0.6	38.0	0
1000	15.1		7.9	70.8	0.6	30.2	0.5	31.0	0
1250	12.8		7.9	70.9	0.5	27.2	0.5	28.0	0
1600	9.4		8.3	71.4	0.5	23.7	0.5	24.0	0
2000	7.9		9.3	71.4	0.6	21.8	0.7	22.0	0
2500	6.7		10.1	71.3	0.8	19.1	0.7	20.0	0
3150	6.2		11.4	70.2	0.8	16.6	0.8	18.0	0
ΔIIC Rati	AllC Rating 25 (Delta Impact Insulation Class) Sum of Deficiencies				32				
ΔHIIC Ra	IC Rating 33 (Delta High-Frequency Impact Insulation Class) Sum of Deficiencies				19

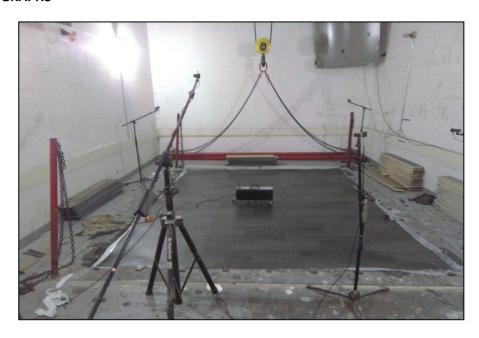
Photo No. 1 Source Room View of Test Specimen Installation

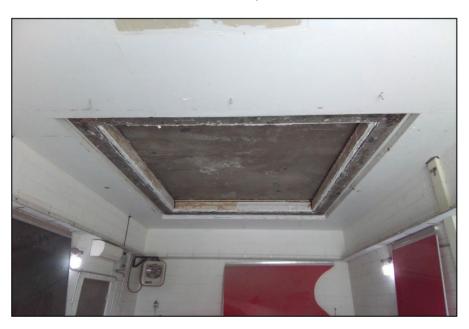
Photo No. 2
Receive Room View of Test Specimen Installation
