VICONIC HEALTH ACOUSTICAL PERFORMANCE TEST REPORT

ASTM E90 AND ASTM E492 TESTING ON 5.5 MM CARPET TILE OVER 11 MM VICONIC SAFETY FLOORING™ UNDERLAYMENT

Open Web Truss - 457 mm

N6747.08-113-11-R0

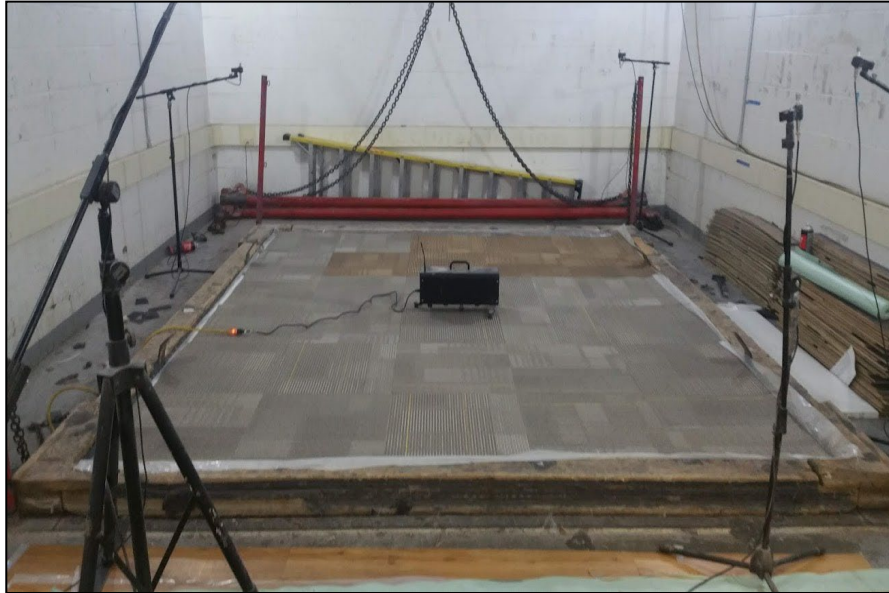
Photo No. 1

Source Room View of Test Specimen Installation

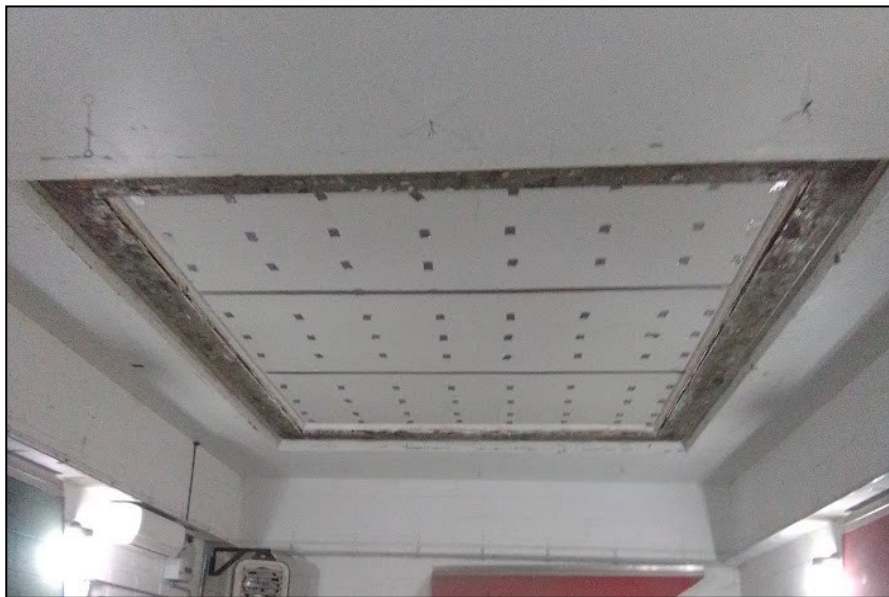
Photo No. 2

Receive Room View of Test Specimen Installation
