Viconic Sporting DBA Viconic Health

Performance Analysis of Vinyl Flooring Systems with and without  
Viconic Fall Defense™

**8/26/2025**

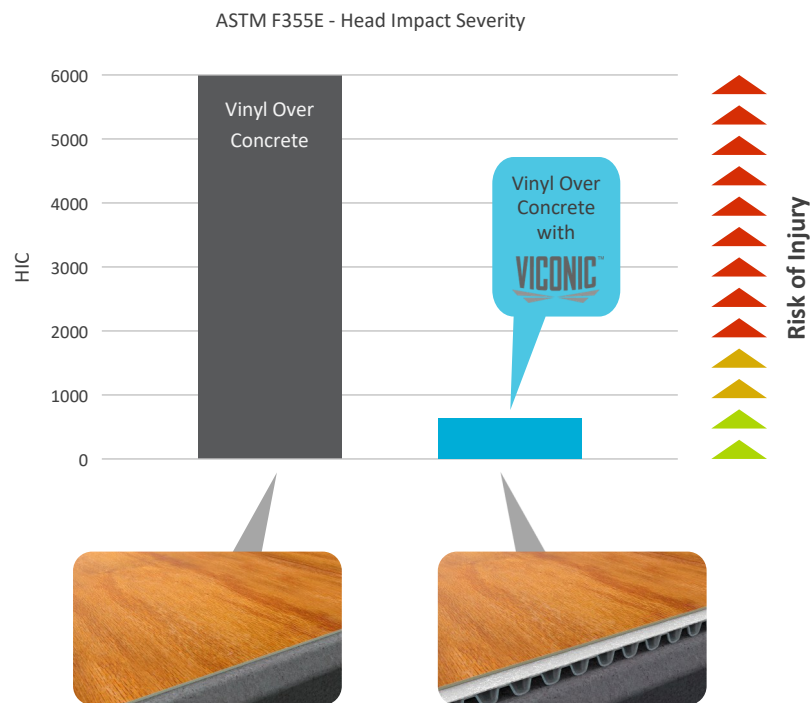
Figure 6: E Missile HIC Results

**Analysis** - Figure 6 clearly shows that the Viconic system substantially lowers HIC values and reduces the risk of injury compared to the baseline system when tested over concrete. The baseline vinyl system is over 6X the federal HIC limit of 1000, whereas the Viconic Fall Defense™ system under vinyl (626 HIC) is well under the federal limit. The Viconic system clearly demonstrates the potential to substantially reduce the risk of TBI and critical injuries.

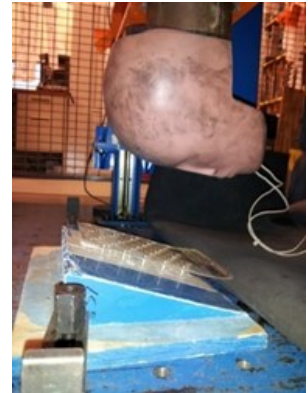
Figure 7: 50th Percentile Male Hybrid III FHM

The FMVSS201u Hybrid III free motion head form (FMH), as shown in Figure 7, is the test device specified by the National Highway Traffic Administration (NHTSA) for determining the risk of head injury inside all passenger vehicles sold in the US. The test device consists of a 4.54 kg (50th percentile male) Hybrid III aluminum head form with human like rubber skin and is equipped with a tri-axial accelerometer. The device output, HIC<sub>d</sub>, is similar to HIC but takes into account movement of the neck during impact.

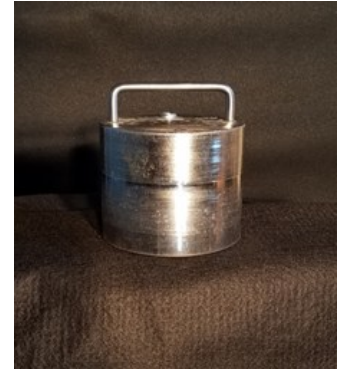
Figure 9: ASTM F355 A Missile

An independent test lab was contracted to evaluate the body impact attenuation properties of Viconic Fall Defense™ using the ASTM F355 A-Missile, which has long been used in North America to gauge the hardness and safety of synthetic turf playing surfaces. The device (as pictured in Figure 9) is a 9.1 kg test missile with a 12 cm flat bottom. The device outputs GMAX, the maximum deceleration experienced during a drop as a multiple of G, the force of gravity. Fields that fail to achieve a GMAX of less than a limit of 200 are deemed unsafe for play. Playing surfaces above this stiffness demonstrate increased risk for bodily injury due to falls onto the surface. Lower values of GMAX during falls are generally considered to present a lower risk of bodily injury. The test protocol requires that the missile be dropped 3 times from a height of 0.61m. The first drop is a conditioning drop; the last two drops are averaged and reported. Figure 10 compares the response of the flooring systems studied here.

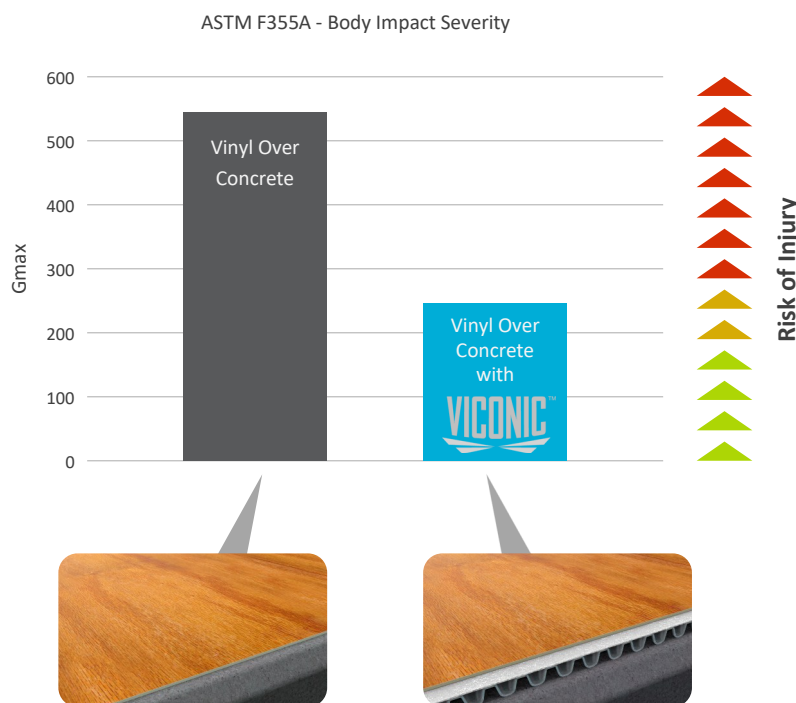
Figure 10: F355 A Missile GMAX Results

**Analysis** - Figure 10 clearly shows that the Viconic system substantially reduces the risk of body injury compared to the baseline vinyl system (545 GMAX). The Viconic system under vinyl (246 GMAX) had values at roughly the allowable GMAX for synthetic turf playing surfaces. The Viconic system's GMAX values are less than half that of the baseline system and demonstrate the capability of substantially reducing the frequency and severity of body impact injuries, including fractures, when compared to the baseline system.

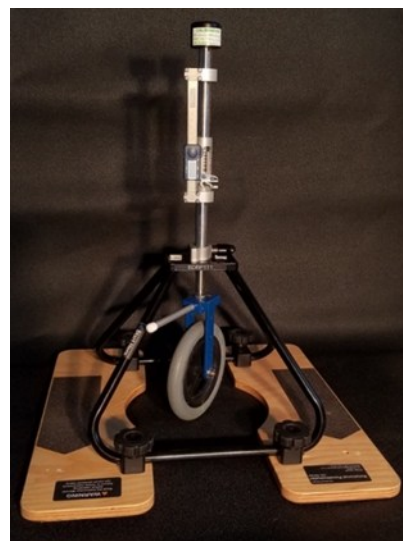
Figure 14: Rotational Penetrometer

Energy absorbing flooring surfaces may absorb impact energy and reduce risk of injury, but if too soft, can restrict mobility and increase the occurrence of falls. Performance testing to quantify the firmness and stability of surfaces was conducted using the Rotational Penetrometer in Figure 14. The device simulates the loading of a wheelchair caster and measures the depth of penetration statically (firmness) and after a 360° rotation (stability). Deformation must be below 7.6 mm for a surface to be considered firm and 12.7 mm for a surface to be considered stable. Although the addition of an energy absorbing underlayment negatively affected the values for both firmness and stability, all values still fell well within the criteria for a firm and stable flooring surface. Figures 15 and 16 compare the firmness and stability of four flooring systems.

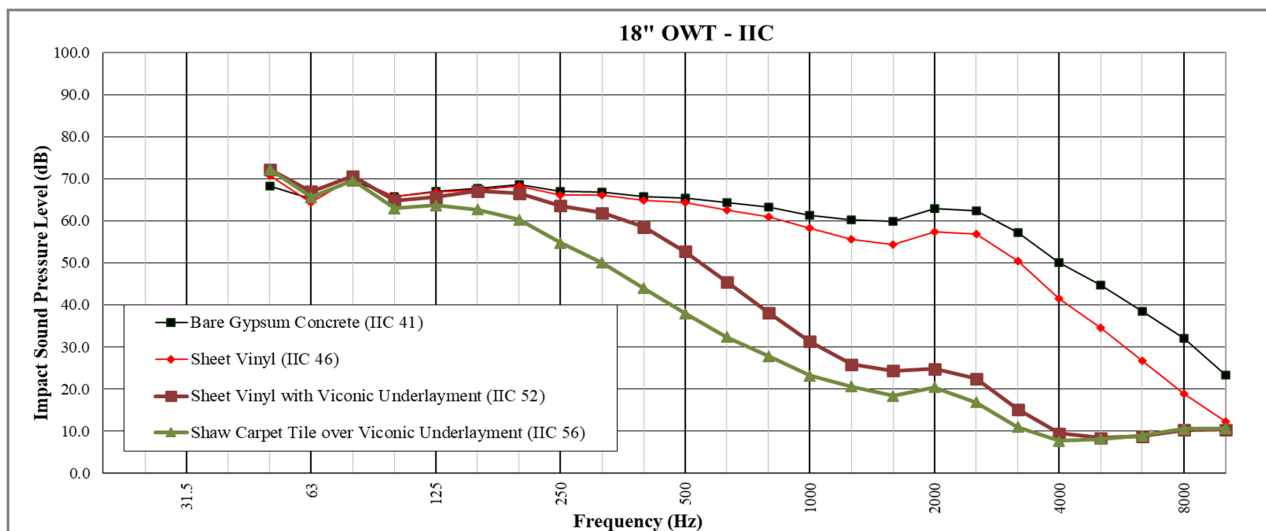
**Figure 21: IIC Curves with Open Web Truss Substrate**

*Analysis* - Figure 21 shows that adding Viconic Fall Defense™ also improves acoustics when using an open web truss subfloor construction. The subfloor without any floor covering had an IIC rating of 41 which increased to 46 IIC with the addition of a commercial vinyl sheet. The same vinyl sheet combined with Viconic increase the IIC value to 52, a 13% improvement. As seen with the concrete subfloor construction, combining Viconic with a commercial grade carpet further reduced sound transmission between rooms, improving to 56 IIC, a 37% improvement compared to the baseline subfloor.

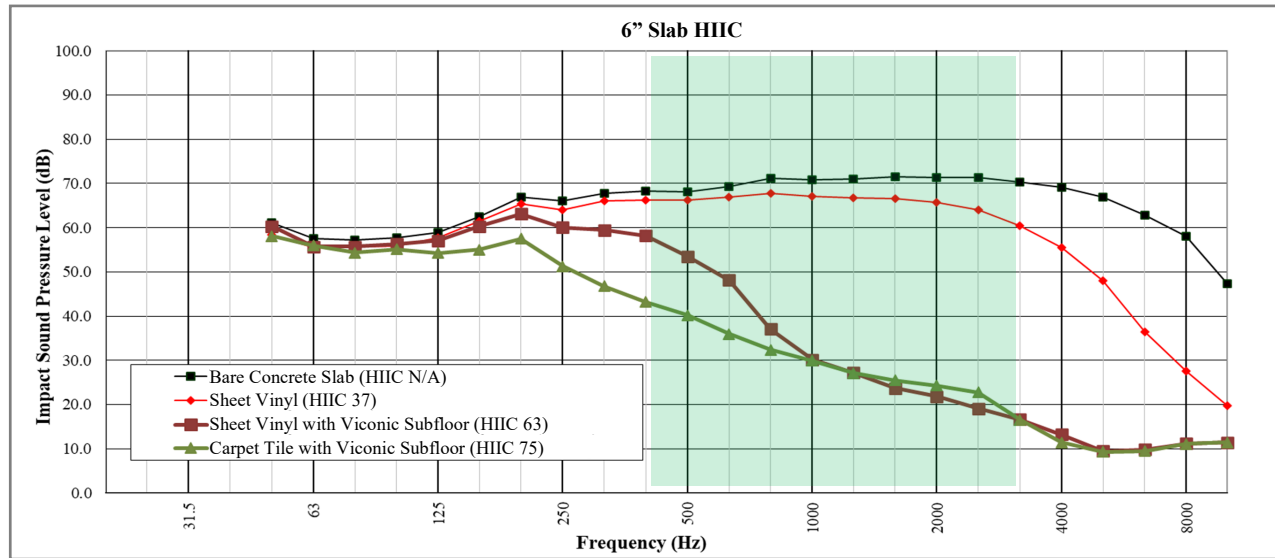
Figure 22: HIIC Test Results

The same test procedure used to determine IIC is used to determine High-Frequency Impact Insulation Class (HIIC); however, only high frequency pressure levels are used in the calculations, specifically 400Hz to 3150Hz. HIIC better highlights the acoustical improvements provided by flooring and underlayments compared to IIC. This test is only conducted over a 152mm concrete slab subfloor. Figure 22 shows the results of the HIIC test and highlights the frequencies used to calculate HIIC.

**Analysis** - Figure 22 shows the significant performance improvement offered by the Viconic Fall Defense™ system when focused on high-frequency sound transmission. HIIC for commercial grade sheet vinyl was increased from 37 HIIC to 63 HIIC with the addition of Viconic, a 70% performance improvement. Implementing a commercial grade carpet further improved acoustic properties, increasing the HIIC value to 75, more than doubling the HIIC value of vinyl over concrete. These results clearly highlight the ability of Viconic to improve facility acoustics and increase quality of life for residents.

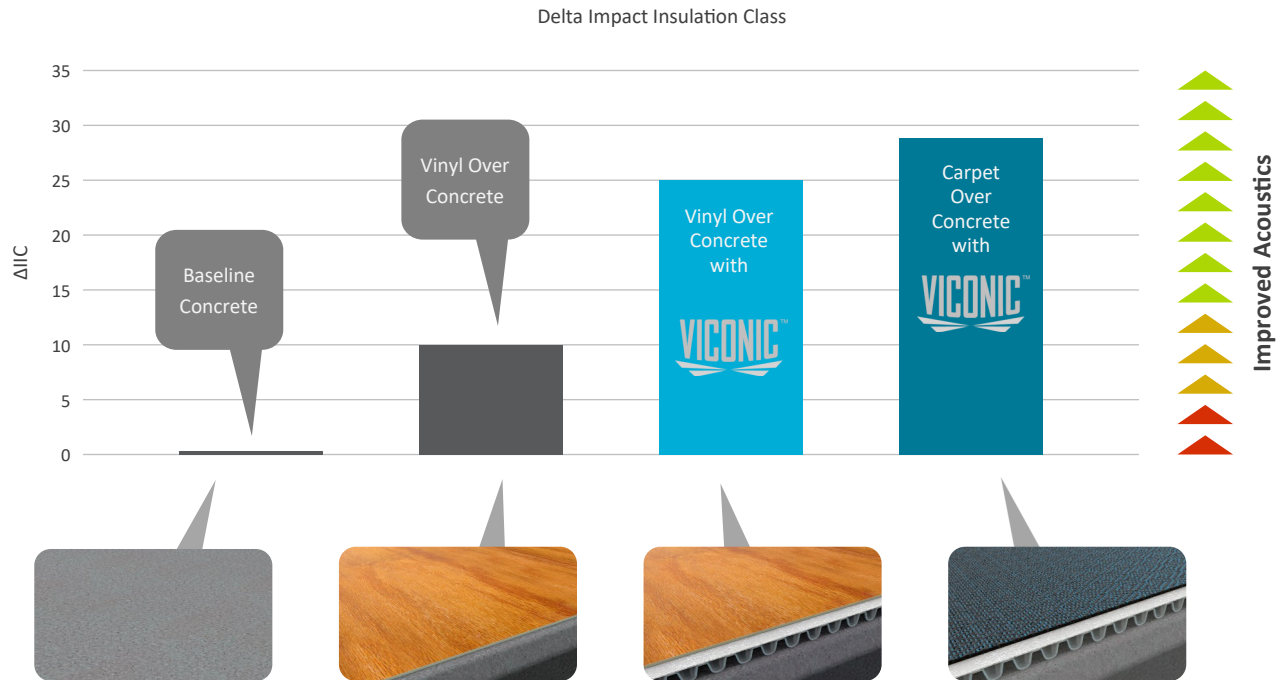
Figure 23: Delta IIC Test Results

Delta Impact Insulation Class ( $\Delta$ IIC) highlights a flooring products ability to reduce sound transmitted between rooms such as footfall noise. The test compares a baseline concrete subfloor to the fully installed flooring system and reports the difference in IIC where the  $\Delta$ IIC for bare concrete is zero. Delta IIC is the best sound rating to consider when comparing the performance of different types of flooring underlayments. Figure 23 shows the improvement in IIC provided by the addition of Viconic Fall Defense™.

**Analysis** - As demonstrated with the IIC and HIIC, Viconic has a much more favorable  $\Delta$ IIC when compared to a traditional flooring system. By definition, the  $\Delta$ IIC of a bare concrete subfloor is zero. The addition of a commercial grade sheet vinyl had a calculated  $\Delta$ IIC value of 10. The addition of Viconic Fall Defense™ to the vinyl system increase  $\Delta$ IIC to 25, a 150% performance increase. Utilizing a commercial grade carpet as the floor covering offered further improvements, increasing  $\Delta$ IIC to 29, a nearly threefold increase compared to the baseline vinyl system. These results highlight the ability of Viconic to reduce sound transmitted through rooms and provide a safer and more comfortable living environment for residents.
